ROAD SAFETY AUDIT REPORT

OR 8: SW 17th Avenue to S 26th Avenue Washington County, Oregon

OREGON DEPARTMENT
OF TRANSPORTATION
REGION 1

KITTELSON & ASSOCIATES, INC.
851 SW 6th Avenue, Suite 600
Portland, OR 97204
(503) 535.7455

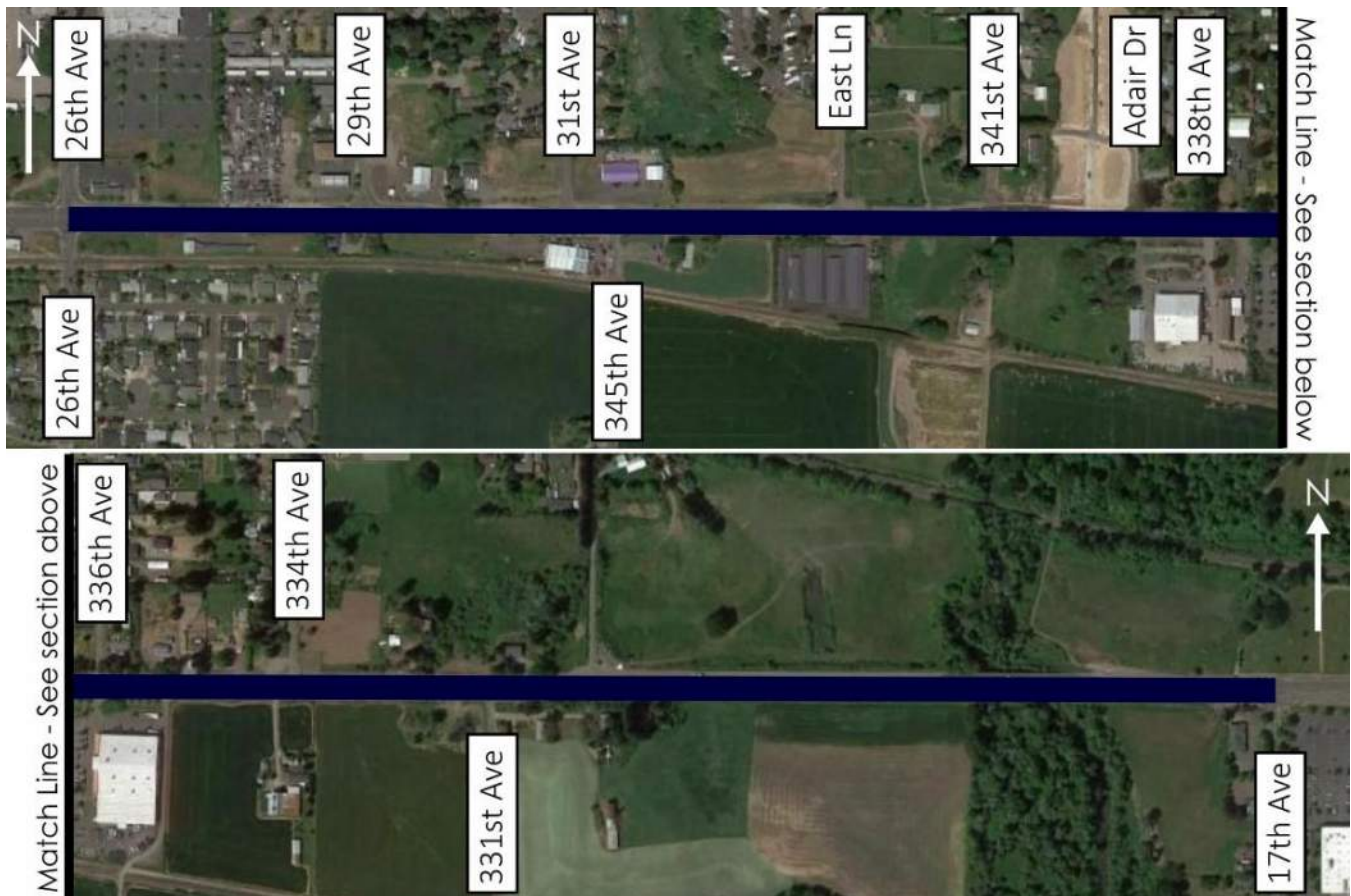
Exhibit 1: RSA Study Corridor Extents

The Road Safety Audit (RSA) Team studied a segment of OR 8 from SW 17th Avenue in Hillsboro, Oregon to S 26th Avenue in Cornelius, Oregon. Exhibit 1 illustrates the extents of the 1.6-mile study corridor, which included portions within the Cornelius and Hillsboro city limits and unincorporated Washington County.

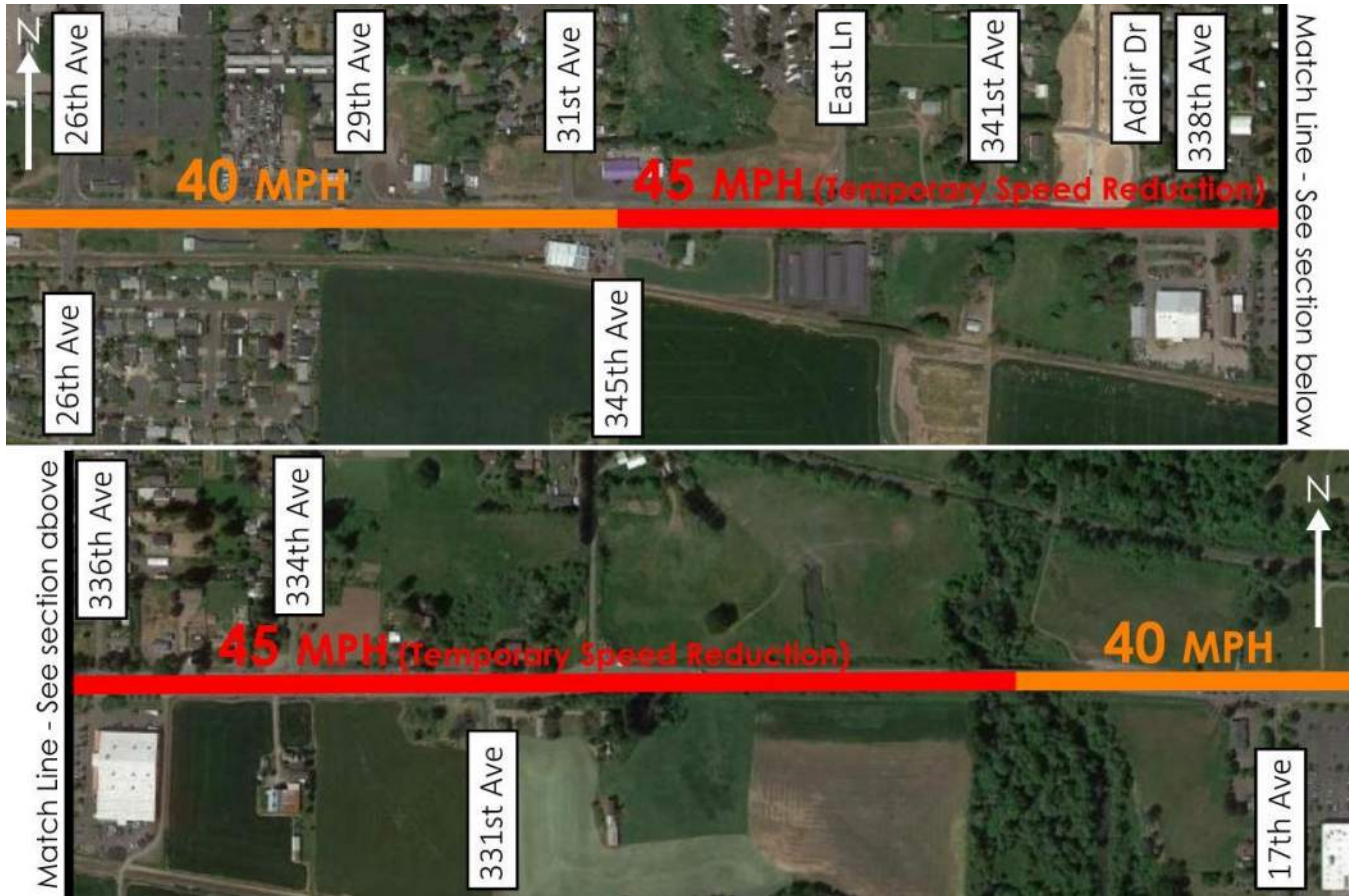
Exhibit 4: Study Corridor Posted Speed

***Temporary Speed Zone reduction from 50 mph until December 31, 2020**

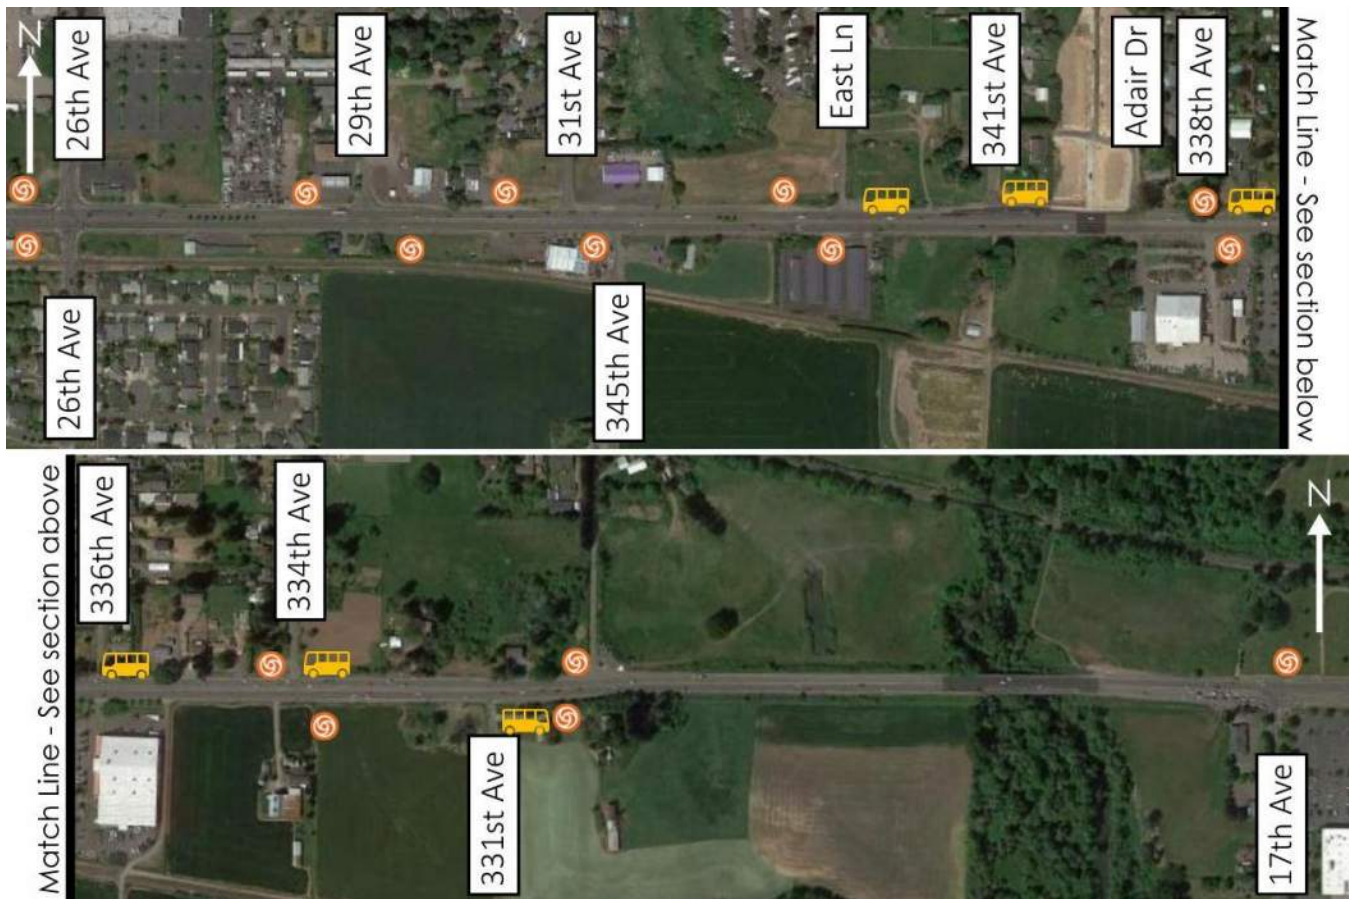
Exhibit 8: TriMet and School Bus Stops Located on OR 8

OR 8 is used for public transit and school bus routes as represented schematically in Exhibit 8. The exhibit shows the approximate location of TriMet and school bus stops on OR 8, as of May 2020.

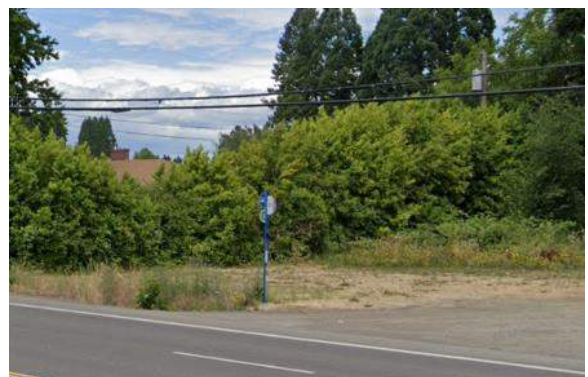
TriMet Line 57 – TV Highway/Forest Grove runs bidirectionally on OR 8. All bus stops are delineated by a pole and signage. The majority of the bus stops require the transit vehicle to stop in-lane to pick up and drop off passengers. Four stops along the western portion of the study corridor include paved bus pull-outs, where the bus pulls out of the travel lane for passenger pickup and drop-off and then pulls back into traffic.

Bus Stop on OR 8

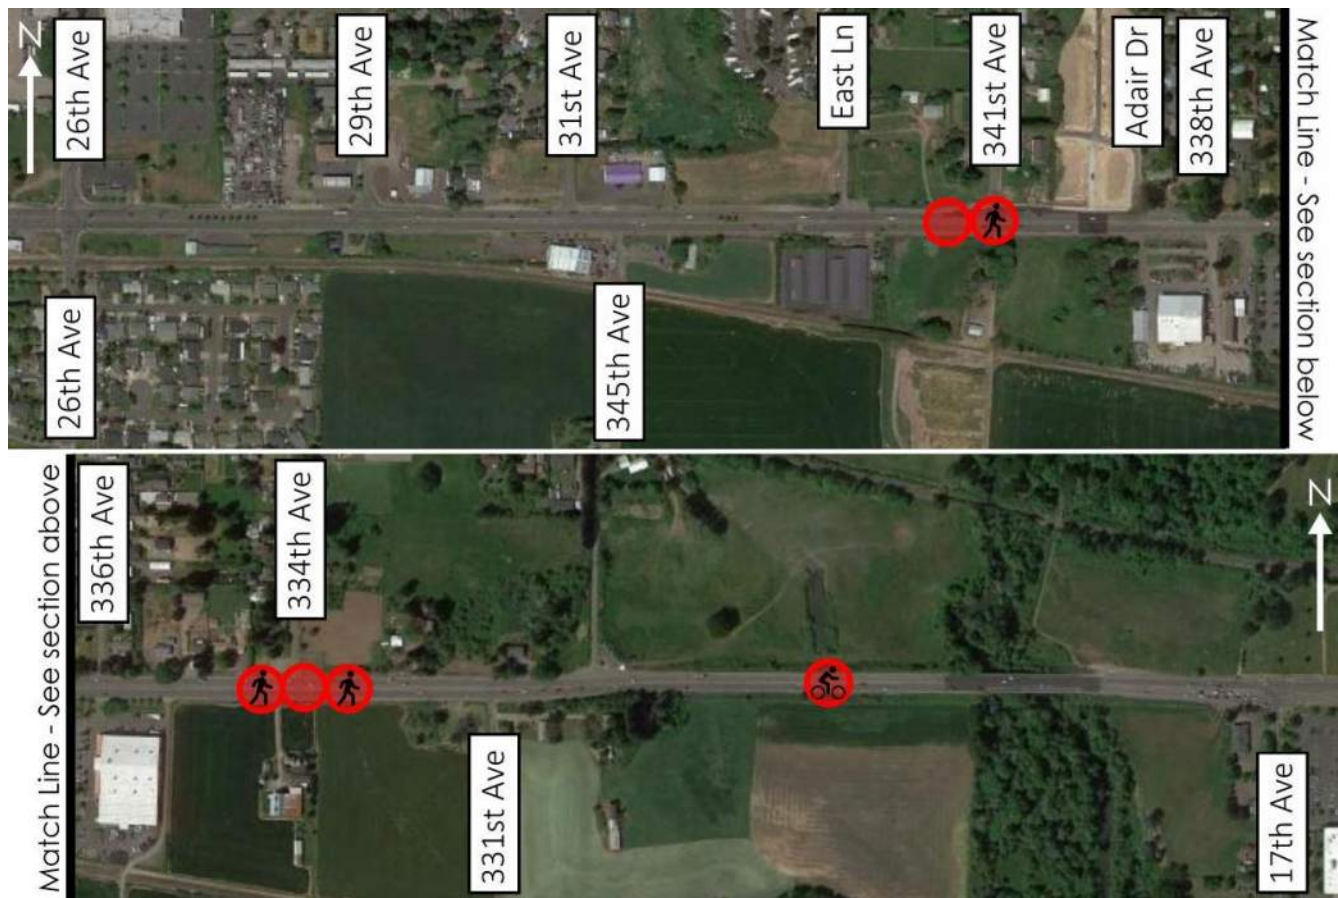
Exhibit 15: Location of Fatal Crashes 2013-2020

- Three pedestrian fatalities near this intersection
 - In-lane bus stops in both directions
 - One of the highest TriMet ridership stops for study corridor
 - Higher turning movement volumes compared to other stop-controlled side streets on the study corridor
 - Tall grass in the northeast corner of the intersection causes difficulty seeing westbound vehicles from the side street
- Minor Intersection: 331st Avenue / North Side Access
 - No westbound left-turn pocket to 331st Avenue
 - Left turns onto 331st Avenue from a westbound leftmost travel lane
 - Overhanging branches encroaching into westbound bike lane
 - Right-of-way (ROW) in the vicinity of the future trail exists for the North Side Access to connect to 334th Ave

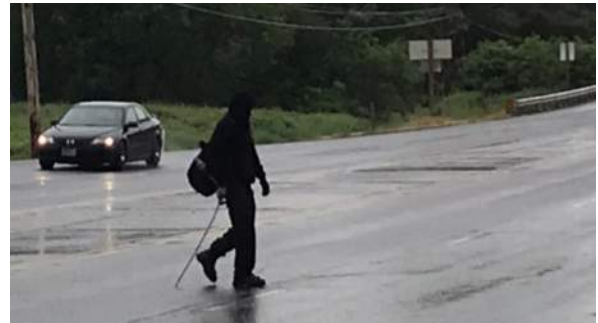
- Pedestrians use the bicycle lane, which has no buffer from the high-speed traffic (see third photo down to the right).
- Access to TriMet and Hillsboro School District bus stops are unsafe
 - OR 8 has been designated a hazard area by the Hillsboro School District for Free Orchards Elementary School. Based on this designation, it is not considered safe for students to use it to walk to school

Pedestrian crossing midblock

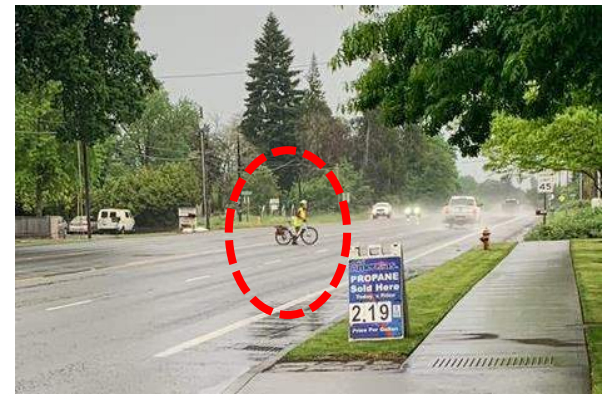
In addition to the crash data, several pedestrian-facility related issues were observed on site. It is difficult to cross OR 8. The following observations were made:

Bicyclist crossing in two stages

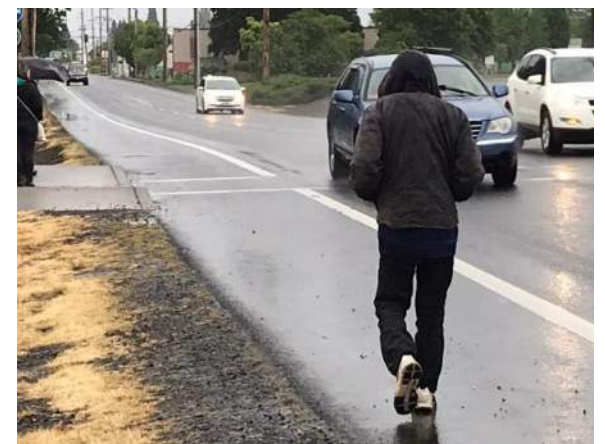
Pedestrian walking in bike lane

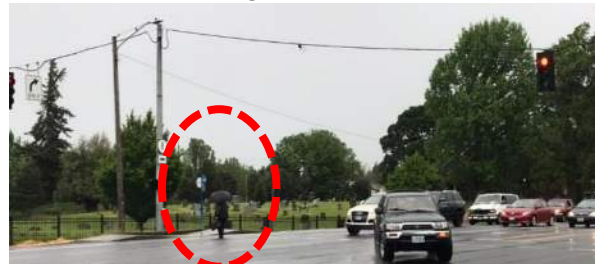
Pedestrian couldn't clear the intersection within the allowed time

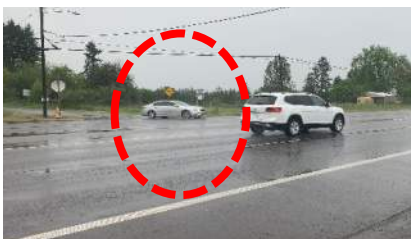
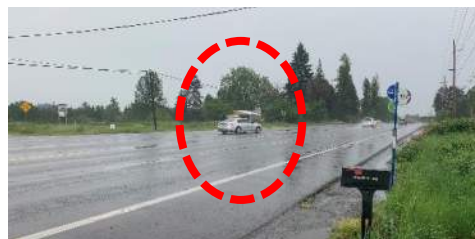
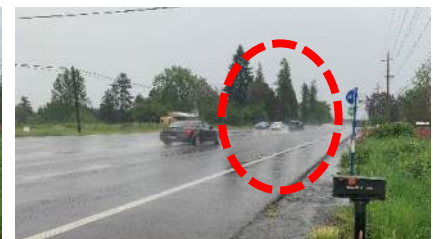
It is difficult for drivers turning left onto the roadway to find gaps to make turning movements. This results in drivers making left turns in two stages. The first stage is to turn into the center median. The second is to merge into the travel lane (as shown in the photos below).

Waiting for gap

Turn into TWLT lane

Accelerate in TWLT lane

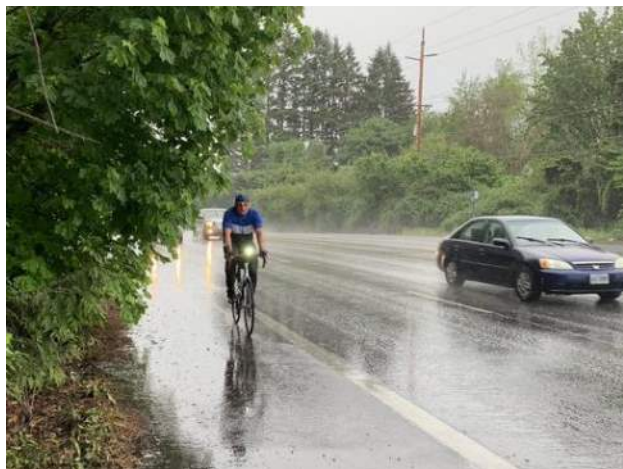
- No separation for vulnerable users, resulting in undesirable speed differential (upper left and right images below)
- Makes school bus and TriMet bus pick-up/drop-off more difficult (lower left image)
- Two-way transit users must cross the street at least once (lower right image)

Bicyclist positioning towards travel lane

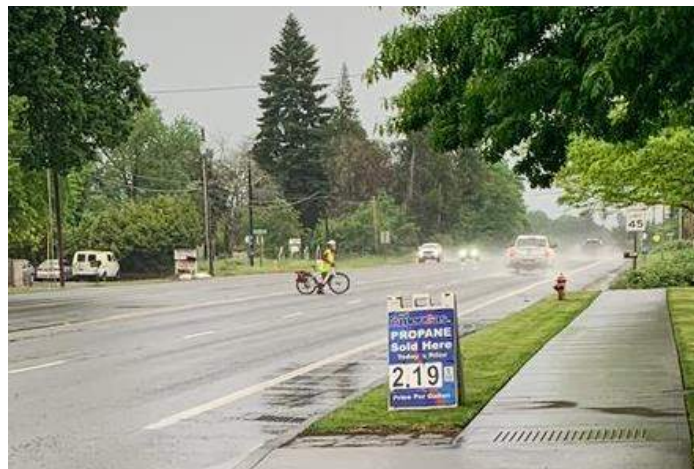
Bicyclist crossing in two stages

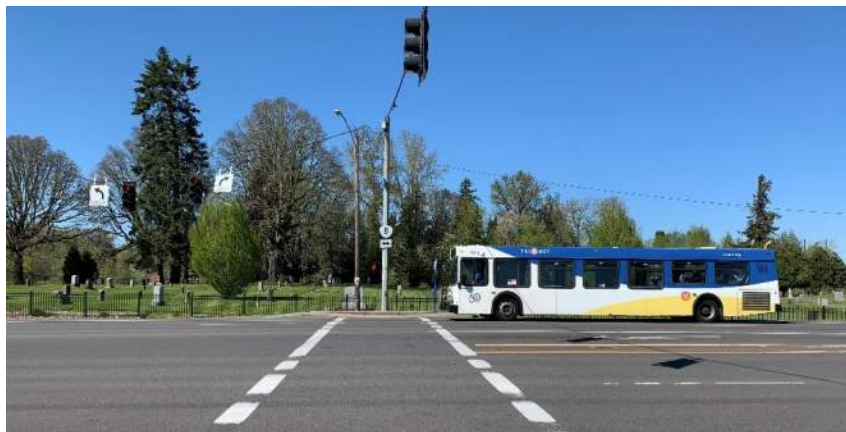
Near-side bus stop at 17th Avenue in Hillsboro

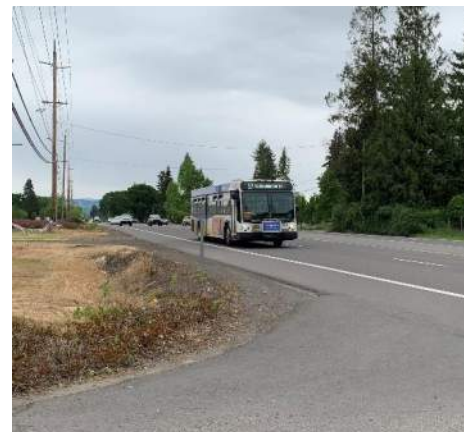
Bus approaching 331st Avenue

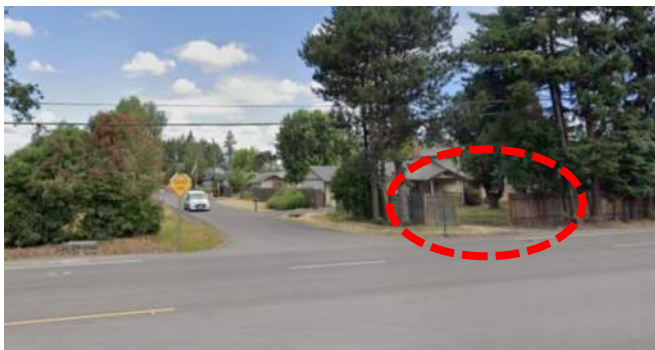
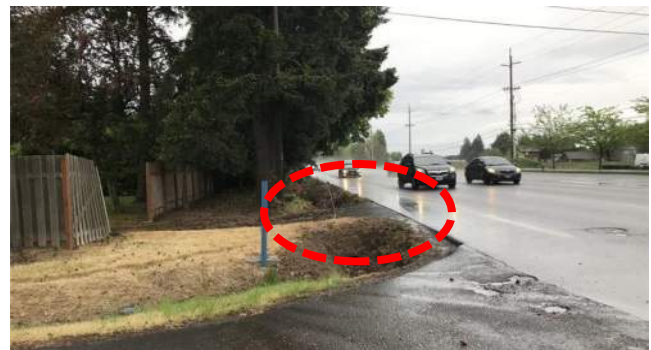
There are many examples of intersections and accesses which are spaced close to each other. One is shown in the photos below:

Driveway near 336th Avenue

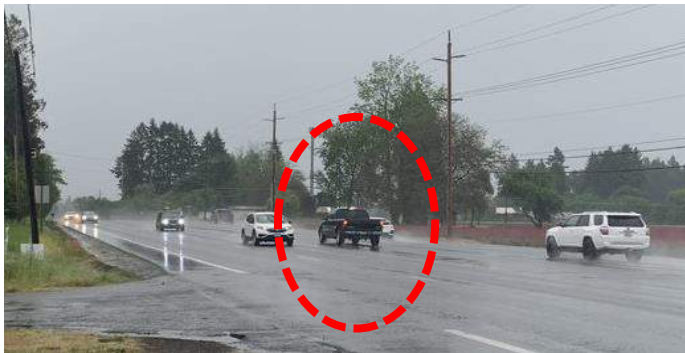
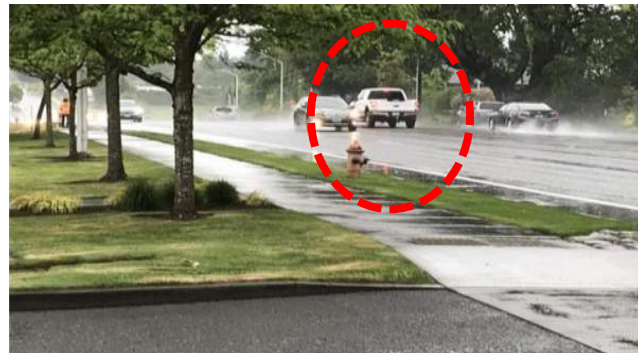
The high-density accesses and unsignalized intersections are an issue because they can create conflicts in the TWLT lane when vehicles are making two-stage left turning movements, as also discussed in the high speed corridor issue section. Examples of vehicles completing a two-stage left turn are shown in the following photos:

Black pickup waiting in TWLT to merge right

White pickup waiting in TWLT to merge right

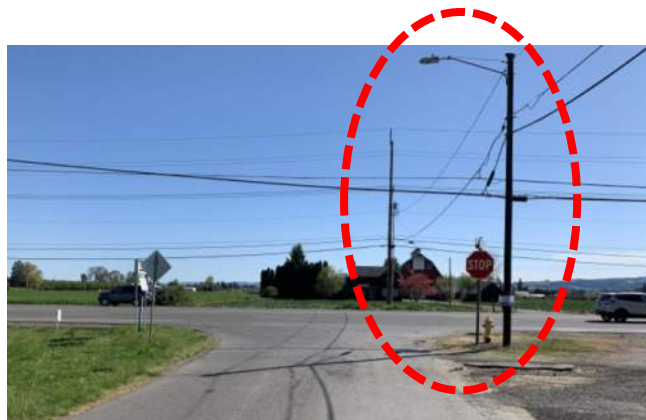
Luminaire oriented towards side street

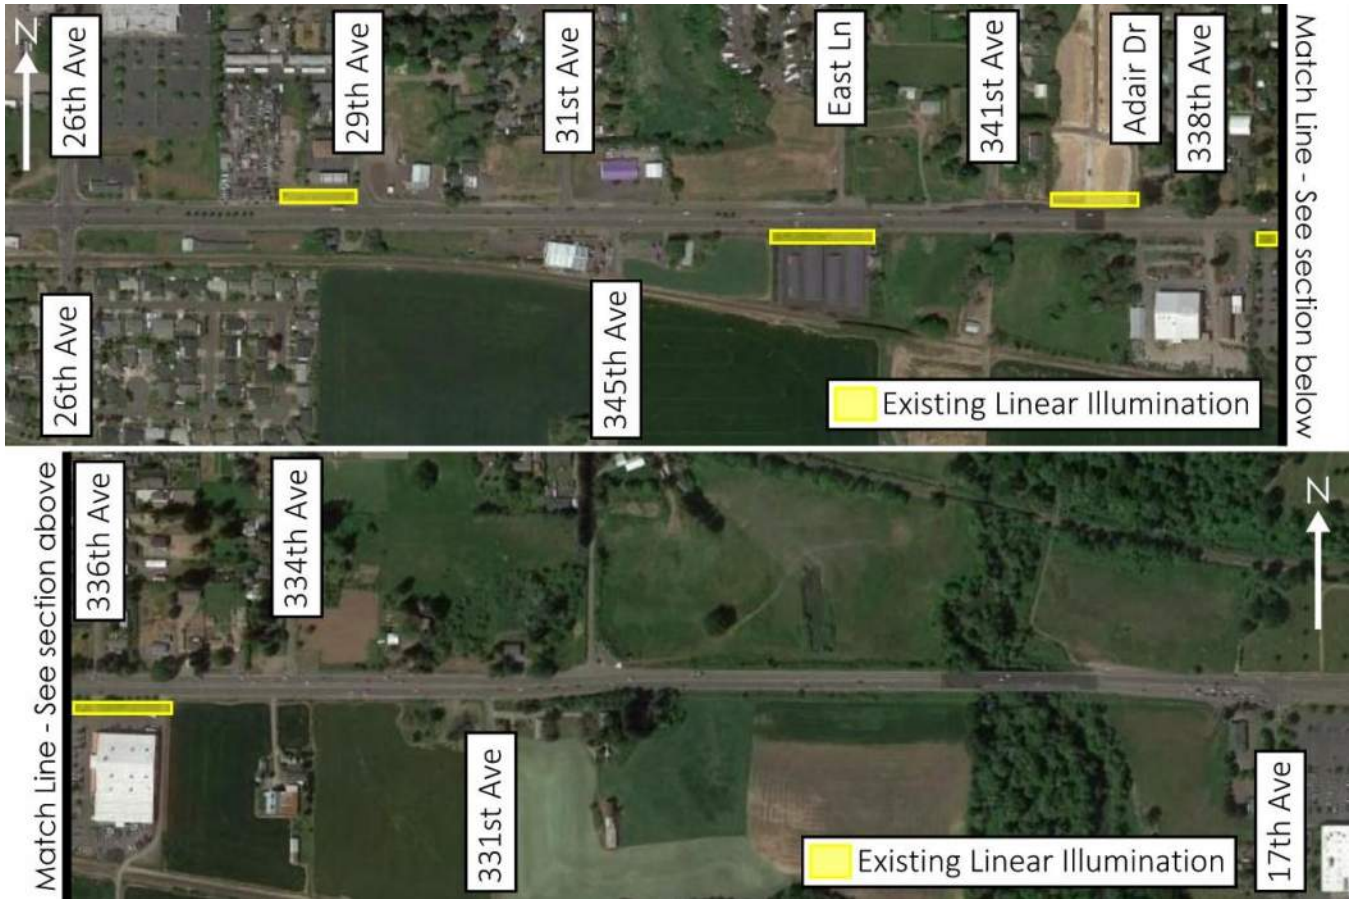
Exhibit 18: Location of Existing Illumination

- Limited lighting created dark conditions
- Business signage created bright spots in the study corridor
- Linear lighting only exists in a few locations and was installed as part of street frontage improvements (see yellow areas in Exhibit 18)

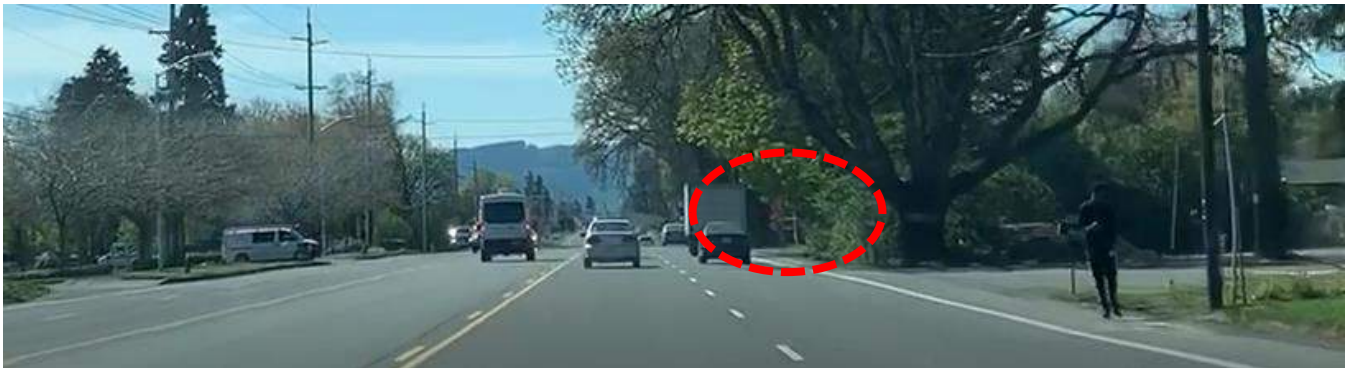
An additional issue identified by the RSA team is limited intersection visibility along the corridor. This means that it is difficult for drivers to identify intersections while they are driving along the corridor. Two examples of intersections that are difficult to see are shown in the photos below:

Traveling westbound—336th Avenue not identified

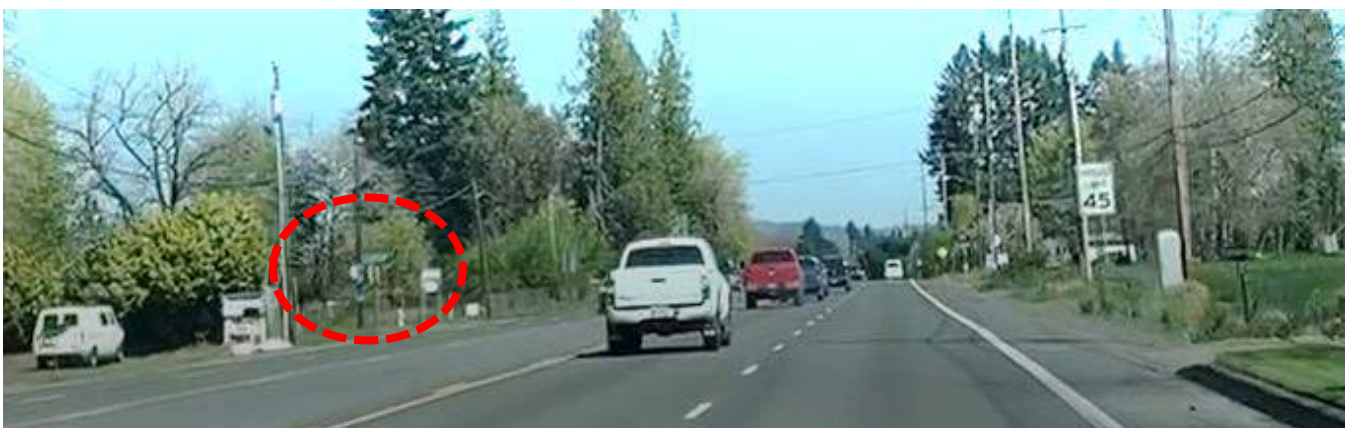
Traveling westbound—334th Avenue not identified

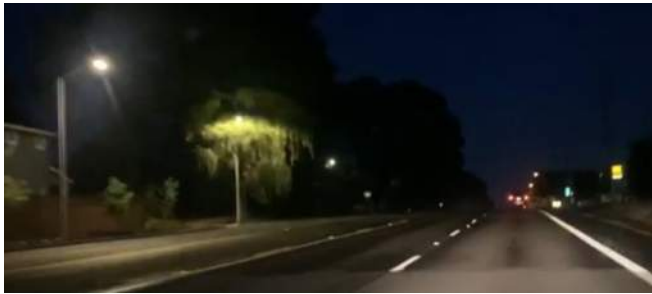
The RSA team also determined that intersection visibility issue is worse at night due to lighting conditions. Intersection visibility is also worse during wet weather and makes it if more difficult for pedestrians to cross. An example of lighting conditions is shown in the photo to the left.

- Luminaires on side streets are located far from the main line
- Dark spots along the corridor
- Bright spots at new development

Nighttime: Lighting near new development only

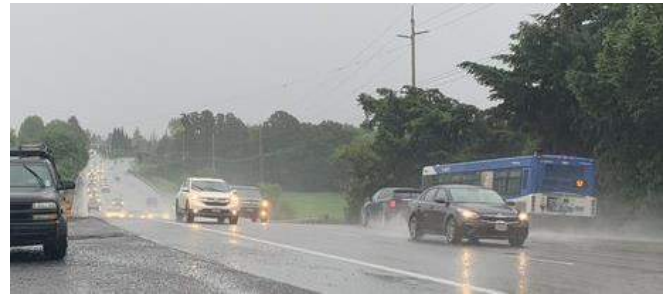
Limited visibility during rain

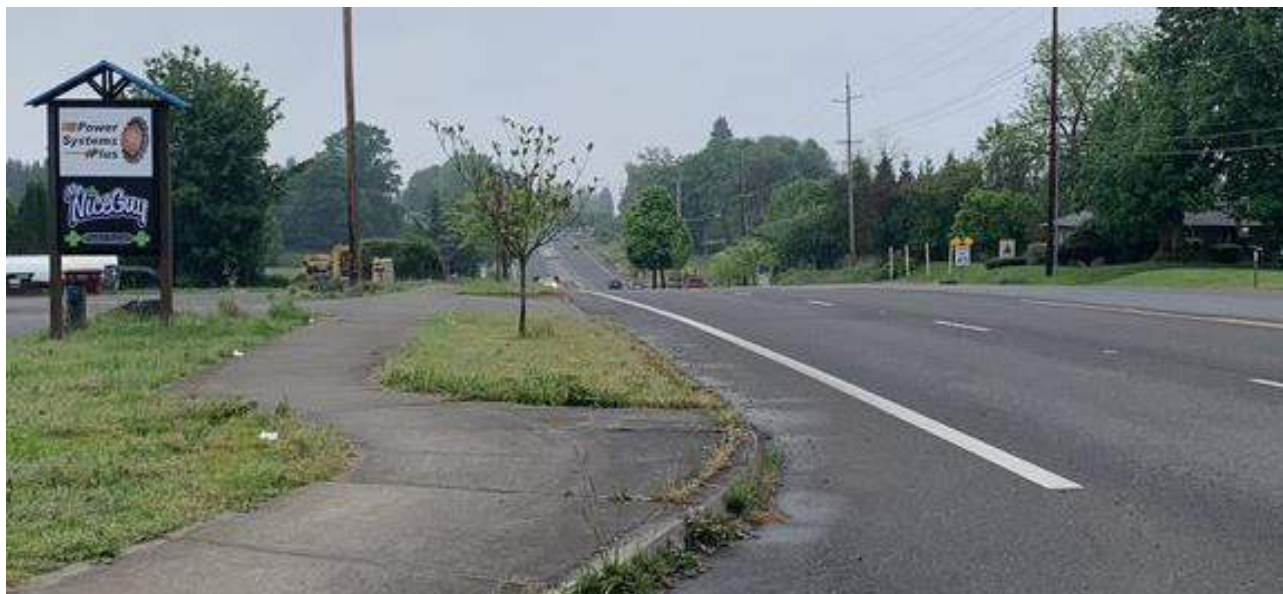
There are two locations where vertical curves of the street limit sight distance and others where intersection sight distance is limited. Photos of these sightlines are shown below. The first photo shows a driver's view to their left (east) at NW 31st Avenue. The second photo shows a driver's view to their right (east) at SW 331st Avenue.

At NW 31st Avenue looking east

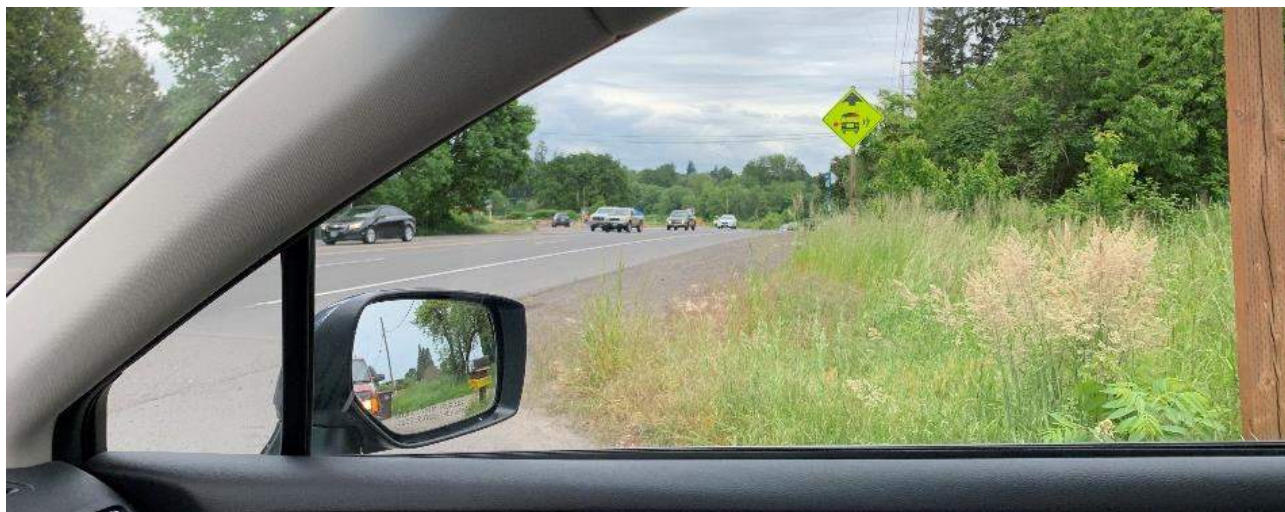
At SW 331st Avenue looking east

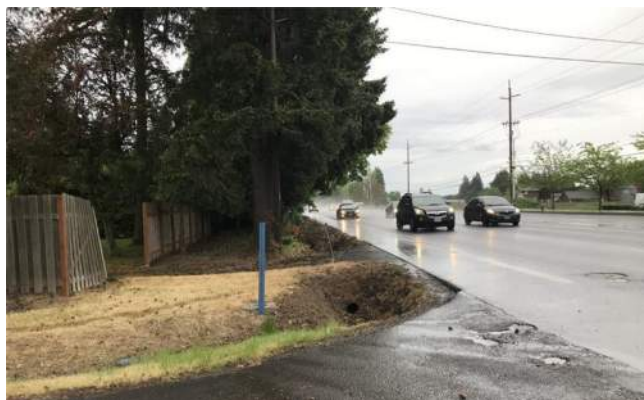
The intersection sight distance (ISD) is also an issue at some of the intersections along the corridor. Vehicles were observed pulling forward past stop bar and/or stop signs to see oncoming traffic. Examples of limited ISD are shown in the photos below:

At 336th Avenue looking east

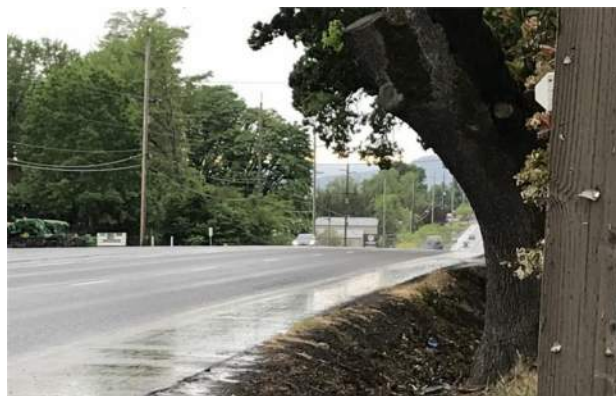
At 336th Avenue looking west

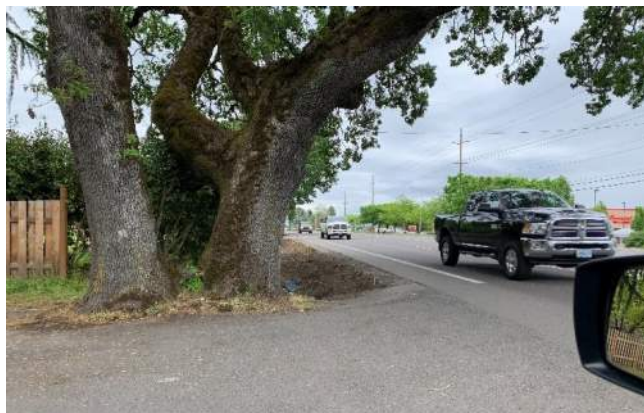
At 338th Avenue looking east

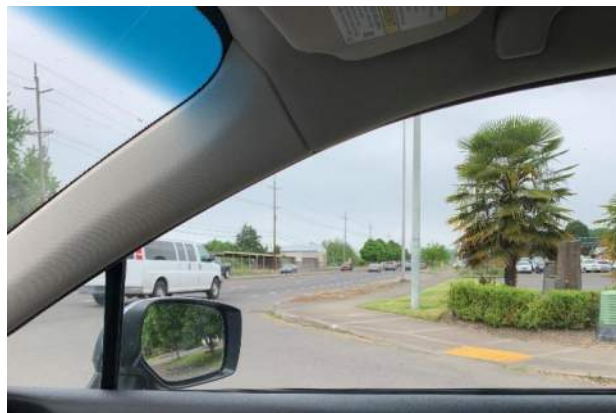
At 29th Avenue looking west

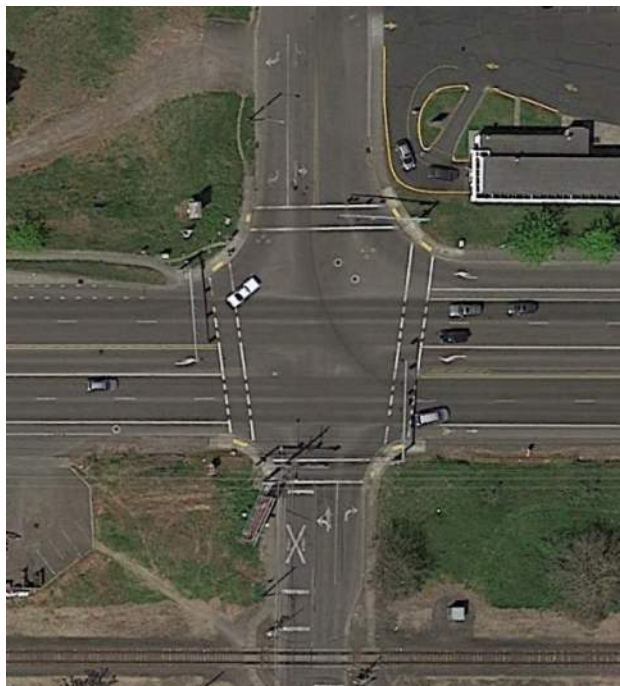
Intersection configuration At OR 8/26th Avenue

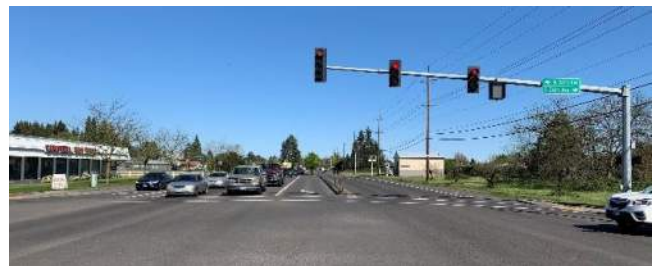
Eastbound permitted/protected left-turn display and low visibility of tubular markers

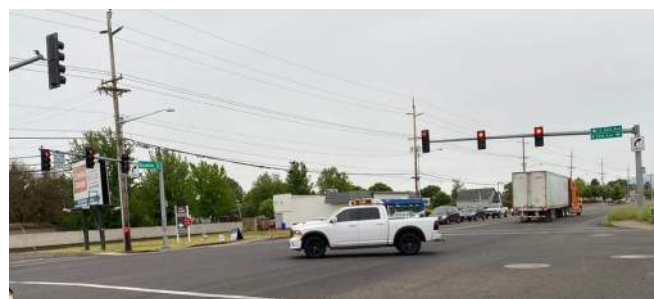
Potential red-light running

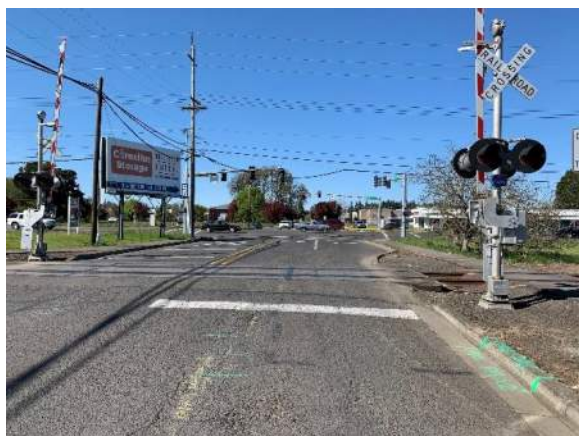
Northbound approach: Shared left/through and right

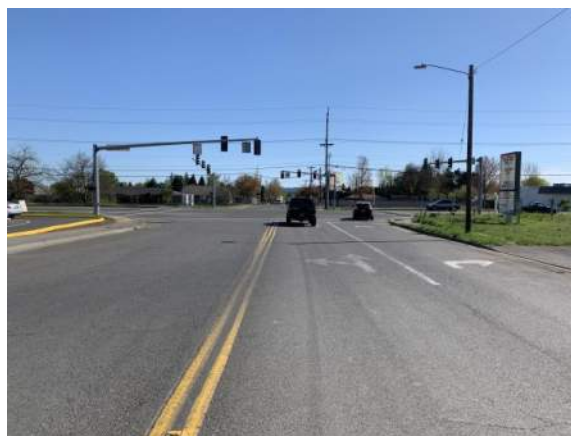
Southbound approach: Shared left/through and right

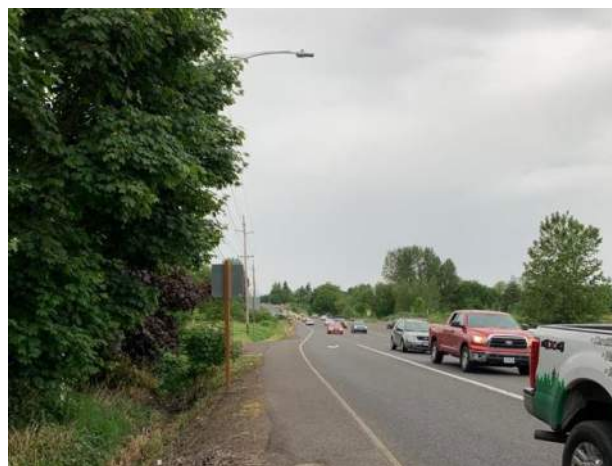
- Observed high TriMet use
- Westbound left-turn Injury A crashes
- Eastbound bike lane dropped prior to intersection
- Northbound left turn:
 - Queues unable to clear in one cycle
 - Failure to yield right-of-way to pedestrians
- Short pedestrian walk times
- Permitted-protected westbound left-turn

Lack of eastbound bike lane at 17th Avenue

- Upgrade/replace signal equipment
- Review the design for the eastbound approach (determine if separation can be provided between the bike lane and the right-turn lane)
- Revisit traffic operations, particularly for the westbound left turn and northbound approach
- Relocate pedestrian pushbutton locations to meet ADA guidance, as needed

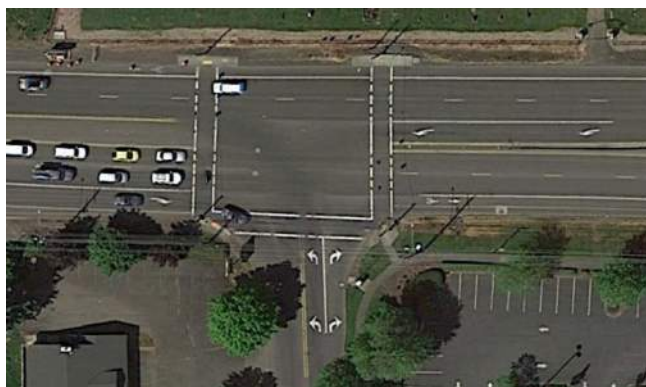
Intersection configuration At OR 8/17th Avenue

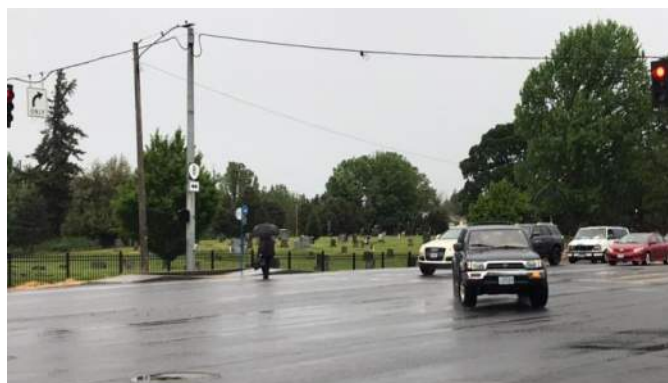
Pedestrian unable to cross within phase at 17th Avenue

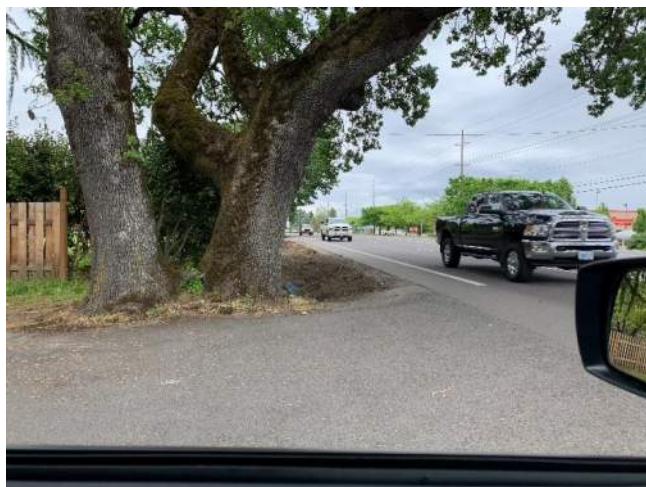
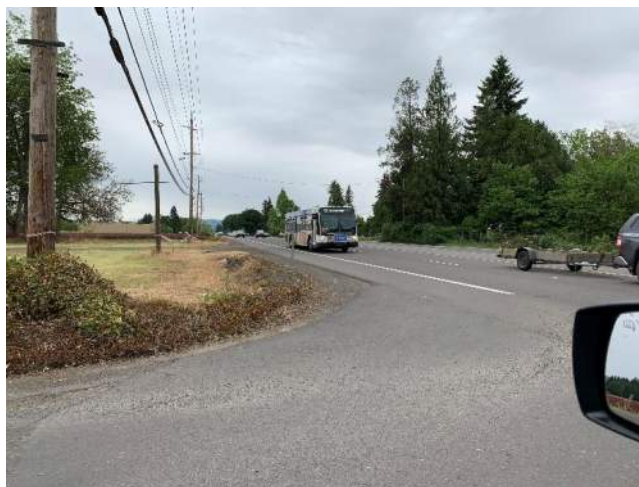
Example of sight distance constraint on the corridor (left photo – 338th Avenue) and one without constraint (right photo – 331st Avenue)

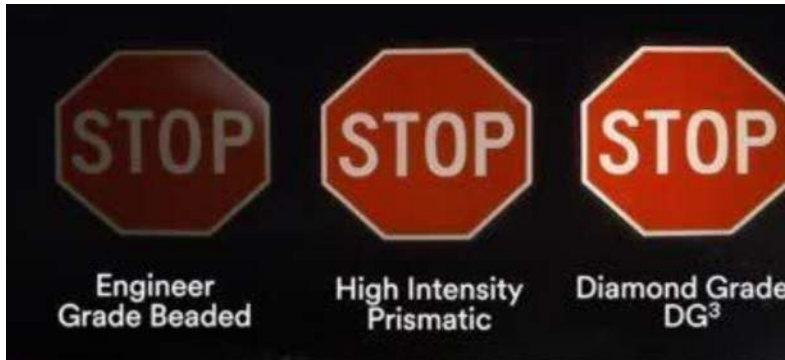
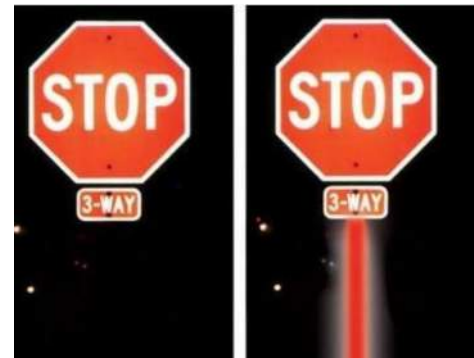
Diamond grade reflective sheeting

Reflective Posts

Improving reflectivity of signs, posts, and pavement markings provides better delineation of the roadway and key intersections for drivers, particularly when traveling at night and in low-light conditions, such as rain. ODOT has a qualified product list (QPL) of reflective sheeting and reflective posts that are approved for use. In addition to reflective treatments, increasing the

text size on signs improves visibility for drivers. Raised or recessed pavement markers can be installed along the roadway centerline and edge-line to increase visibility of the lane.

Install recessed or raised pavement markers
CRF: Up to 15% reduction in night-time crashes
ODOT Countermeasure Number: RD12

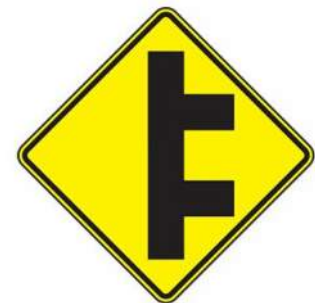
W2-8

Example of MUTCD sign indicating multiple intersections/ driveways ahead

- Increasing reflectivity, as discussed in the previous section, with reflective flexible delineators along intersection corners
- Installing street name signage on both sides of the street
- Installing advance warning signs for stretches of the corridor with a high density of access points

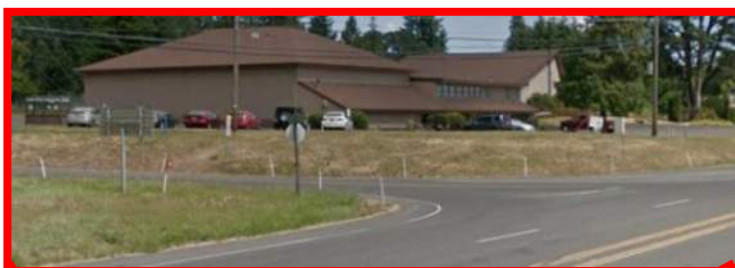
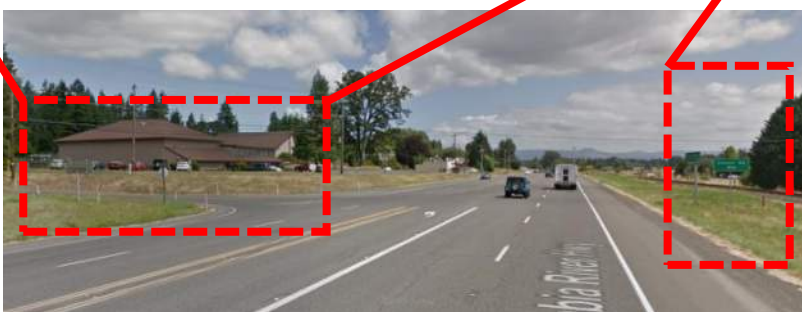
Example of delineators and additional street name signs to increase intersection visibility on Highway 30

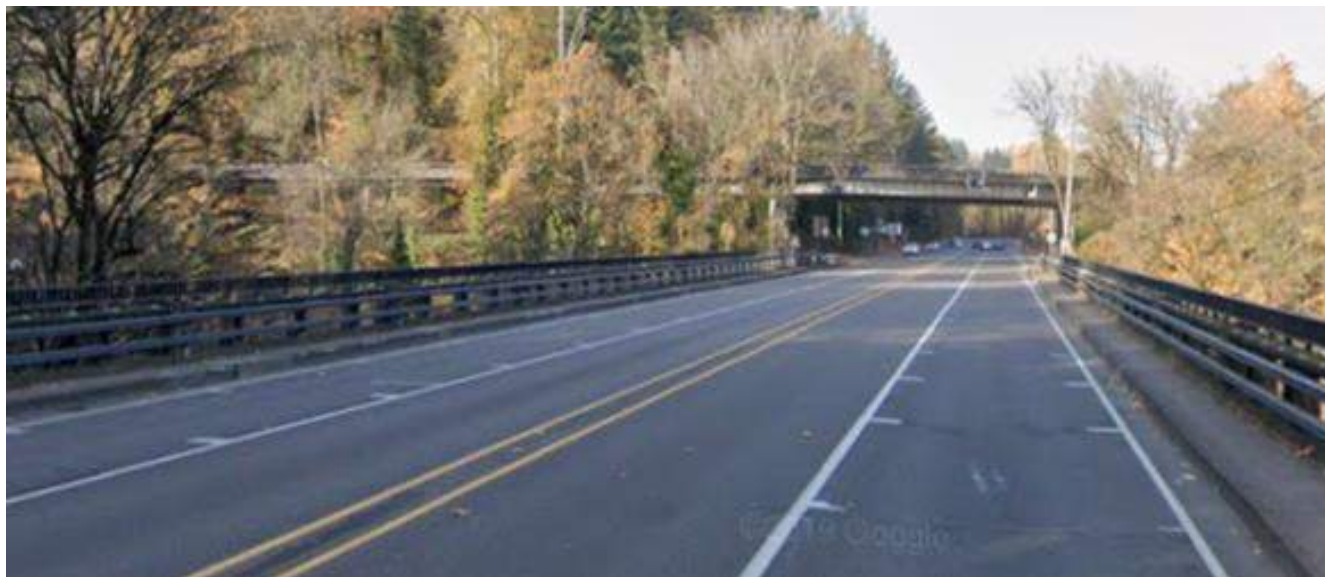
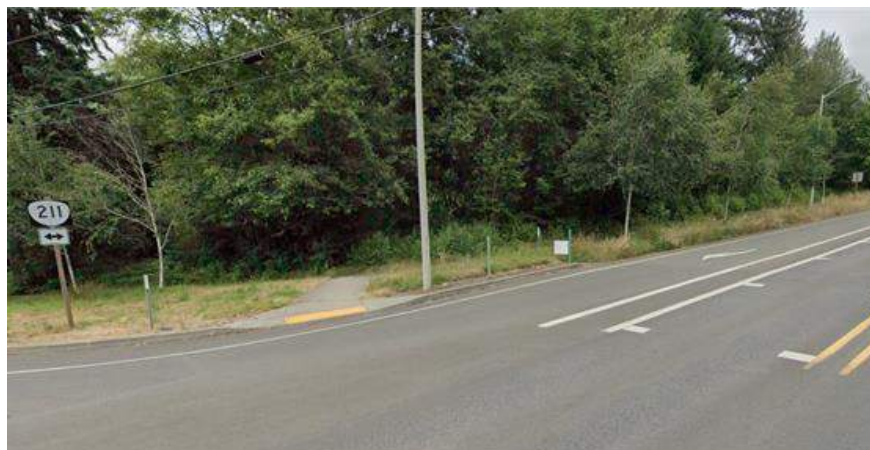
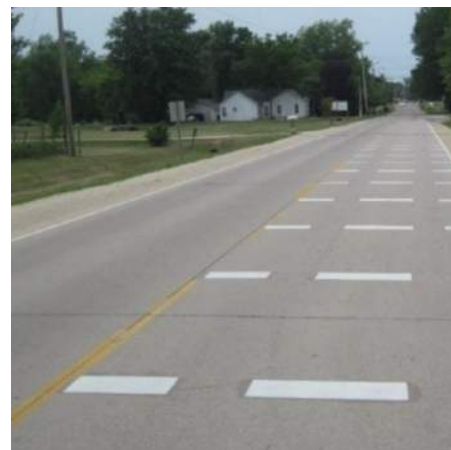
Example installation of in-lane lateral striping on Barbur Boulevard south of Sandy

Example in-lane lateral striping installation, OR 211 south of Sandy

Optical Speed Bars

Installing in-lane lateral striping in conjunction with speed feedback signs has been shown to be effective at reducing speeds along corridors. The striping creates the illusion of a narrower lane and encourages slower travel speeds. *NCHRP Report 613: Guidelines for Selection of Speed Reduction Treatments at High-Speed Intersections* provides additional information about this treatment. Photos below illustrate example installations along Barbur Boulevard and OR 211 south of Sandy.

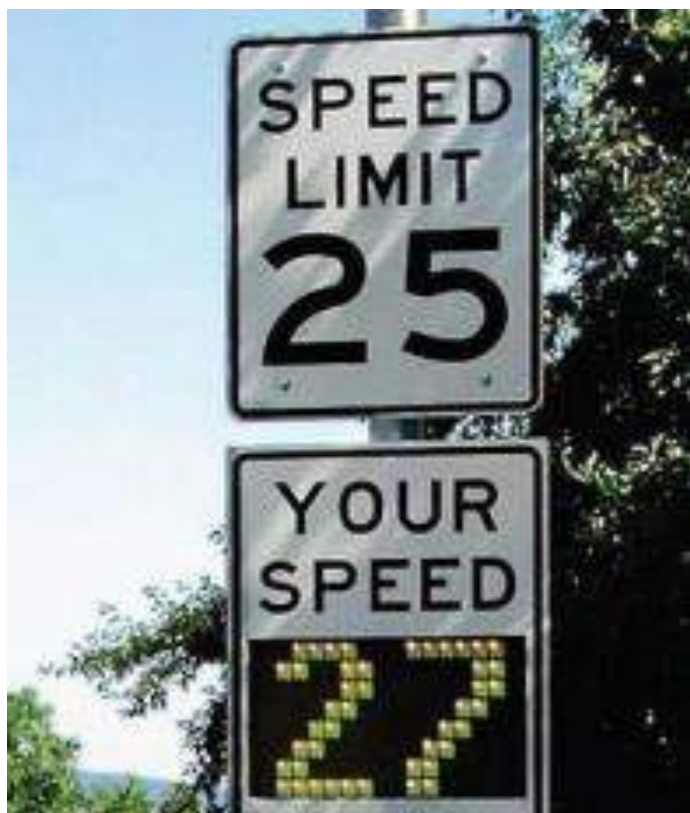
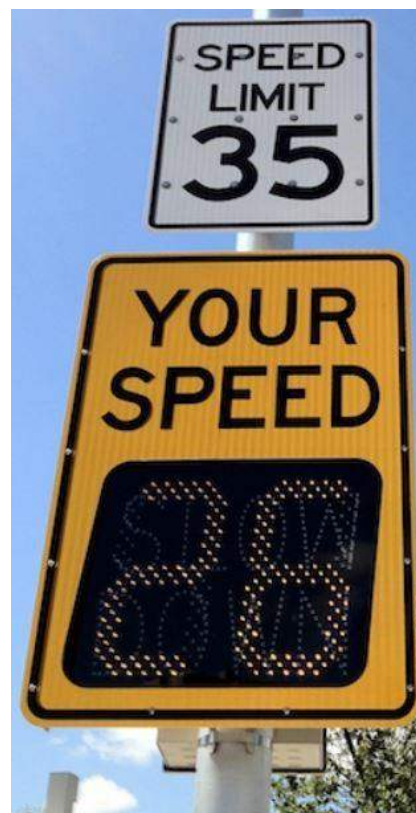
Speed feedback sign example

CRF: 41% reduction in all crashes

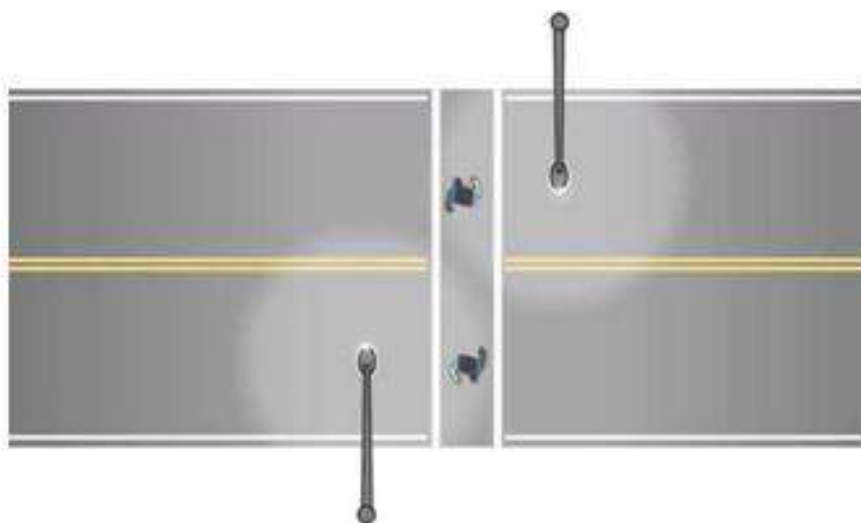
Exhibit 22: Illustration of illumination located in advance of pedestrian crossing to highlight pedestrians and the crosswalk for approaching drivers
