ROAD SAFETY AUDIT REPORT

OR 8: SW 17th Avenue to S 26th Avenue Washington County, Oregon

OREGON DEPARTMENT
OF TRANSPORTATION
REGION 1

KITTELSON & ASSOCIATES, INC.
851 SW 6th Avenue, Suite 600
Portland, OR 97204
(503) 535.7455

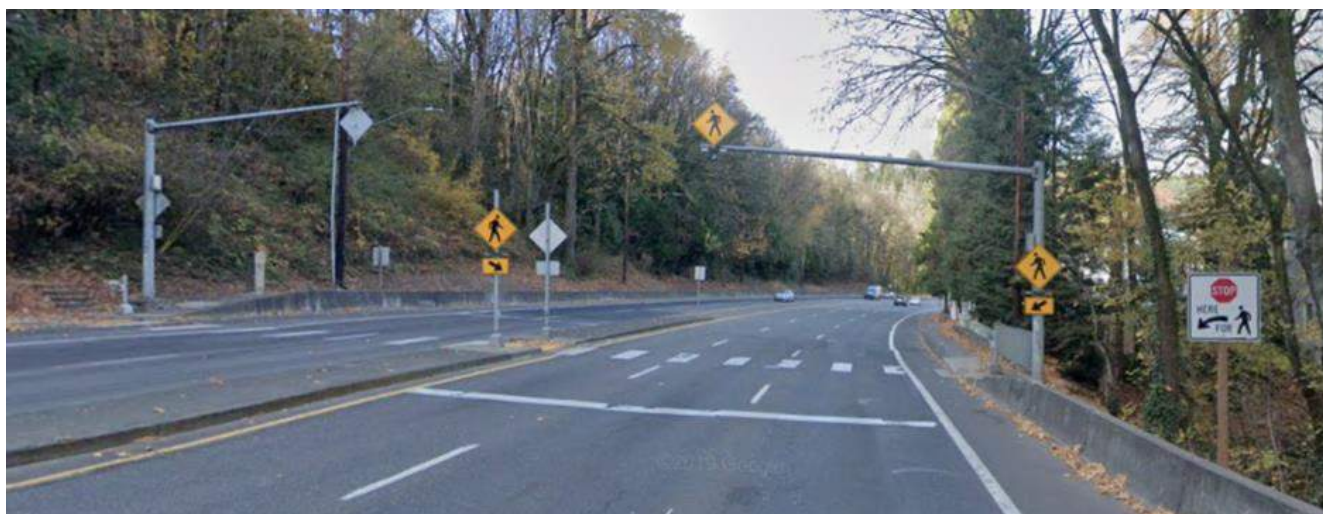
Example of Overhead RRFB Installation

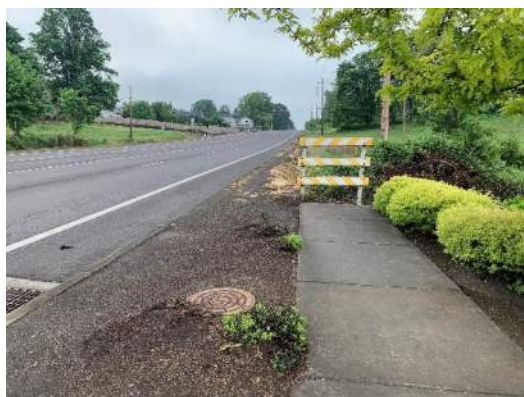
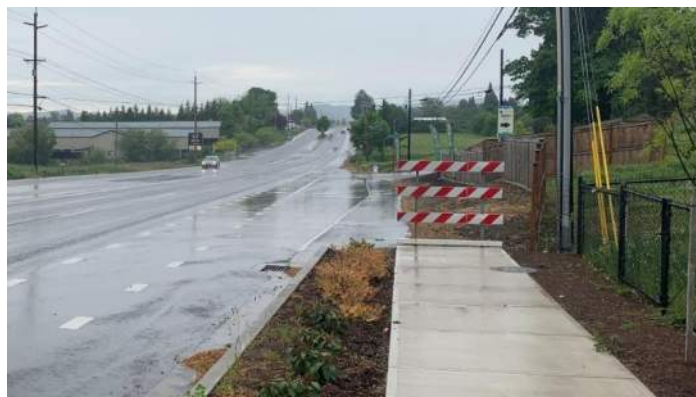
Examples of locations on OR 8 where sidewalk ends abruptly under current conditions

Completing sidewalk infill provides dedicated space for pedestrians to travel along the corridor without encroaching on the roadway. Sidewalk infill should be coordinated with enhanced crossings and bus stop locations, as illustrated in the previous section, between East Lane and 334th Avenue. Sidewalk should connect to crossings to create a connected system for pedestrians. A temporary asphalt path may be constructed in the near-term for connectivity; concrete sidewalks with full right-of-way (ROW) and stormwater considerations may follow later as a mid-term project or street frontage improvements.

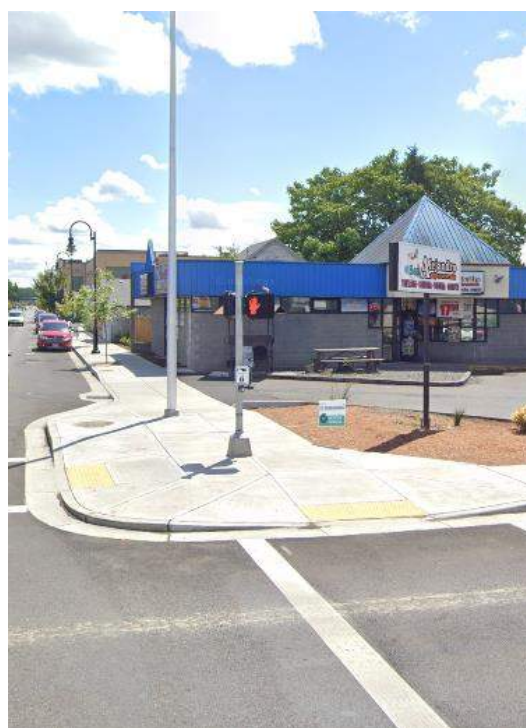
Illustration of ADA-Compliant Pedestrian Ramps

ODOT is following a systematic approach to update pedestrian ramps. There is a STIP project to upgrade pedestrian ramps along the OR 8 corridor. However, the study corridor is not included in the funded project and currently lacks consistent, ADA-compliant ramps. The RSA Team suggests that ODOT coordinate appropriate staff to identify potential project overlaps and needs along the study corridor.

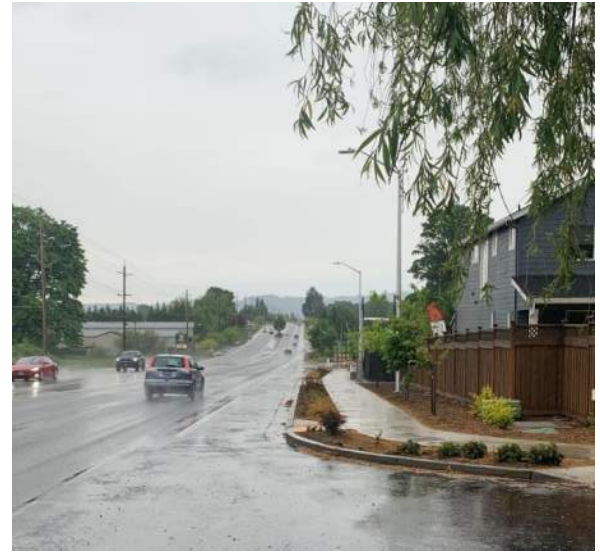
Example of Short Segment of Existing Lighting on the Corridor

Illumination can help raise visibility at key locations and potential conflict points, such as intersections, crossings, and bus stops. However, it may not be appropriate to install segment lighting along OR 8, given the rural nature of the study corridor between Hillsboro and Cornelius. Illumination may be appropriate at the transition segments into each city. Further evaluation is needed to review each intersection and bus stop to determine if lighting is needed. In addition, lighting should be implemented as part of the enhanced pedestrian crossings and sidewalk suggestions from the RSA (refer to near-term Suggestions). There may be opportunities to coordinate with new developments and incorporate lighting improvements in conjunction with their frontage improvements.

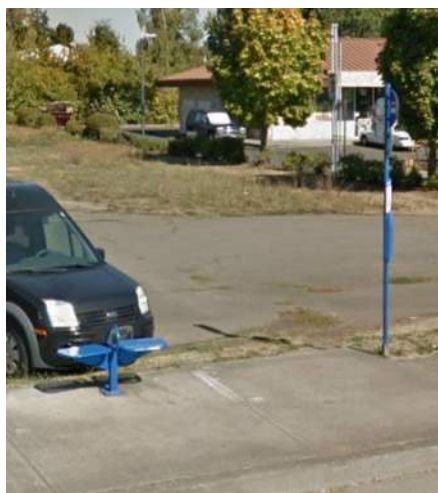
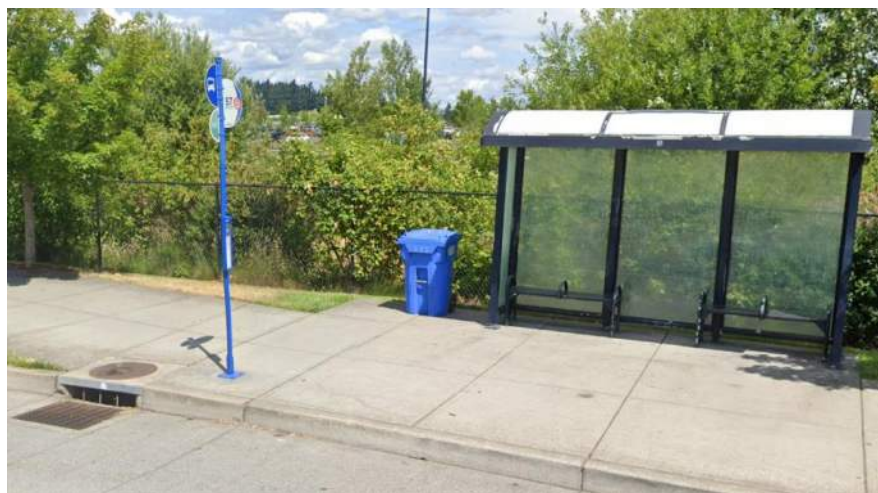
Types of TriMet stop amenities

Providing bus stop amenities such as covered seating in a pull-out location provides dedicated space for transit users to wait for the bus rather than waiting on the side of the road where they are more vulnerable to traffic. The RSA team suggests local agencies coordinate with TriMet to provide bus stop upgrades in tandem with the enhanced pedestrian crossings. A review of each specific site should be conducted to determine appropriate amenities, which may include benches and a shelter. The determination of level of bus stop amenities will be completed by TriMet. The review should also consider whether modifications to bus operations and bus stop consolidation is desired and feasible to provide bus pull-outs rather than in-lane stops.

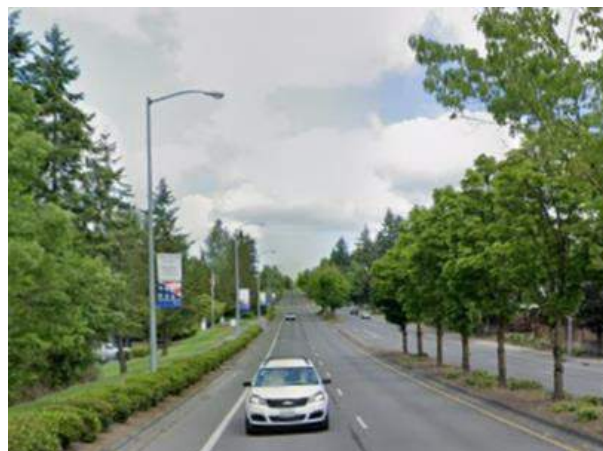
Typical roadway lighting along a multilane facility

Install Corridor Illumination

As the OR 8 becomes more developed, it will take on more of a suburban/urban context and it may be appropriate to consider lighting throughout the study corridor, in addition to the key locations identified in the near- and mid-term suggestions. The RSA team suggests a corridor-wide evaluation to identify segments, key intersections, and crossings for illumination. ODOT and local agencies will work together to evaluate and consider corridor illumination. Local agencies will need to coordinate on maintenance and ongoing operating responsibilities. In addition, the evaluation should consider potential options to mitigate light pollution and conduct community outreach.

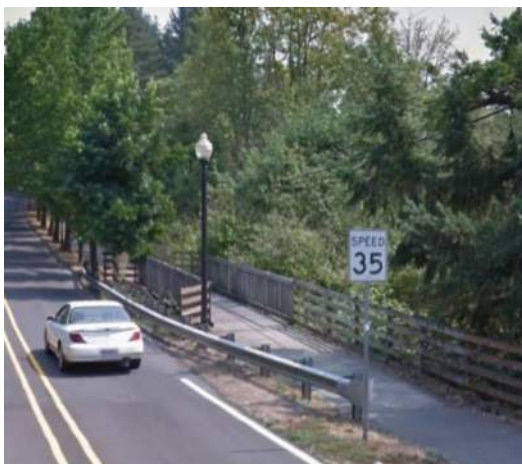
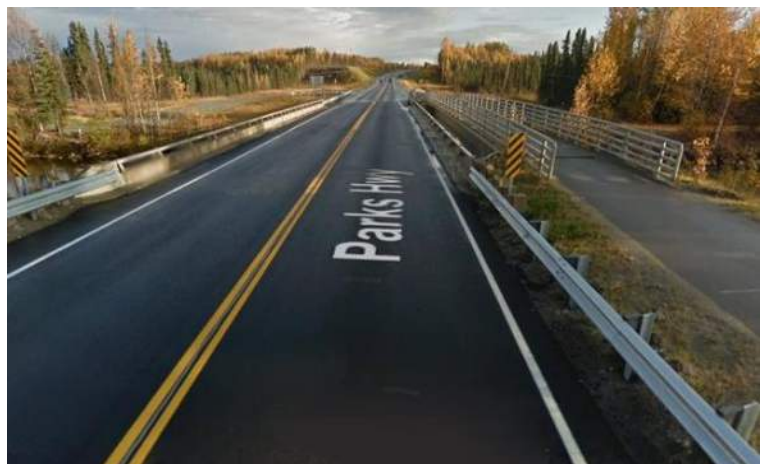
Examples of Shared-Use Paths

It should be noted that Cornelius, Hillsboro, Forest Grove, and other agencies are continually reviewing the pedestrian and bicycle needs of this area. One potential project is the Council Creek trail along the ODOT rail tracks that run parallel of OR 8 to the north. Additionally,
